Field Report for Airborne Data Collected In Support of US EPA Region 6 South 4 Group Fire 02 December 2019

On 27 November 2019 an explosion and subsequent fire was reported at the South 4 Group facility located near Port Neches, TX. Local information indicated that at approximately 0100 (central) a large explosion rocked the area. The explosion subsequently caused a massive fire at the facility in a short amount of time. Local officials ordered an initial evacuation of 0.5 miles on 27 November 2019 which was extended to 4 miles around 1430 (central). The evacuation order was lifted at 1000 (central) on 29 November 2019. Reported onsite products include various olefins, butadiene, and isobutylene. The geographical coordinates of the facility are 29.9222N, 95.0547W (figure 1).

The US EPA Region 6 requested that the ASPECT system be deployed to provide monitoring support beginning on 27 November 2019. This report summarizes findings observed during the two missions flown on 02 December 2019.

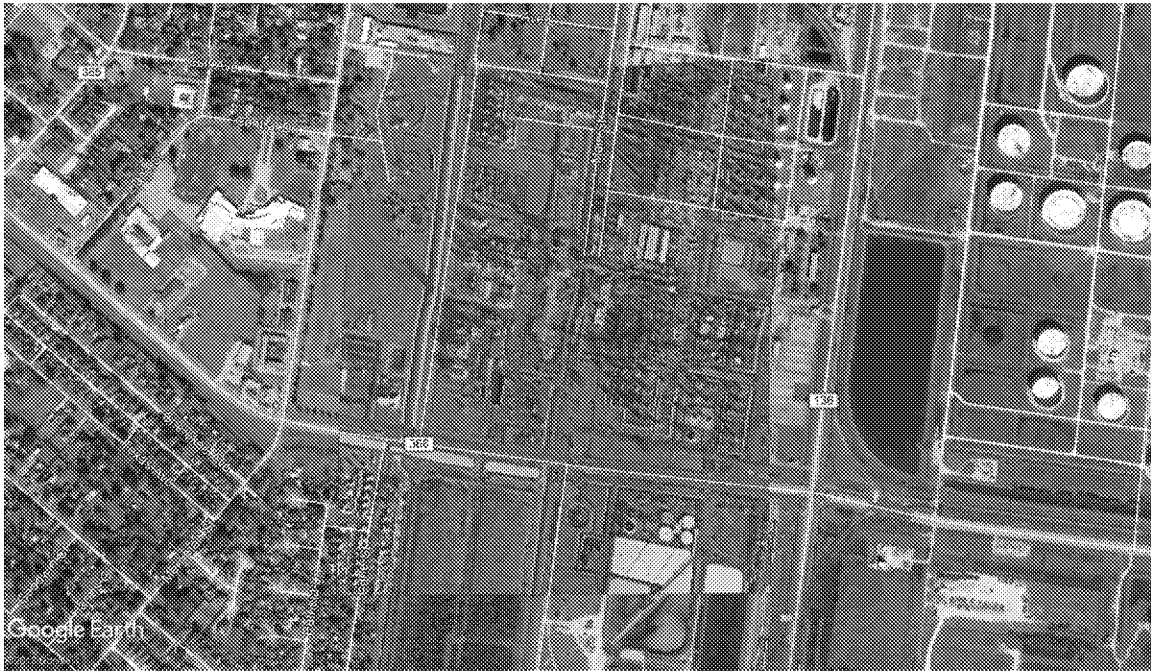
A total of 2 test and 8 data collection passes were made in the proximity of the fire and an infrared line scanner image was generated for each pass. Figure 3 shows a typical 3-band infrared image obtained from data collected for Run 8. The thermal environment of the unit tends to be low. At the time of the IR collection, no water cannon or emissions can be seen in the image. Figure 4 shows a close-up thermal analysis of the production facility again showing very little elevated temperature other what appears to be one hot spot on the northern side of the process unit.

Figure 3: -- 3 band IR image, Flight 10, Run 8, South 4 Group Fire

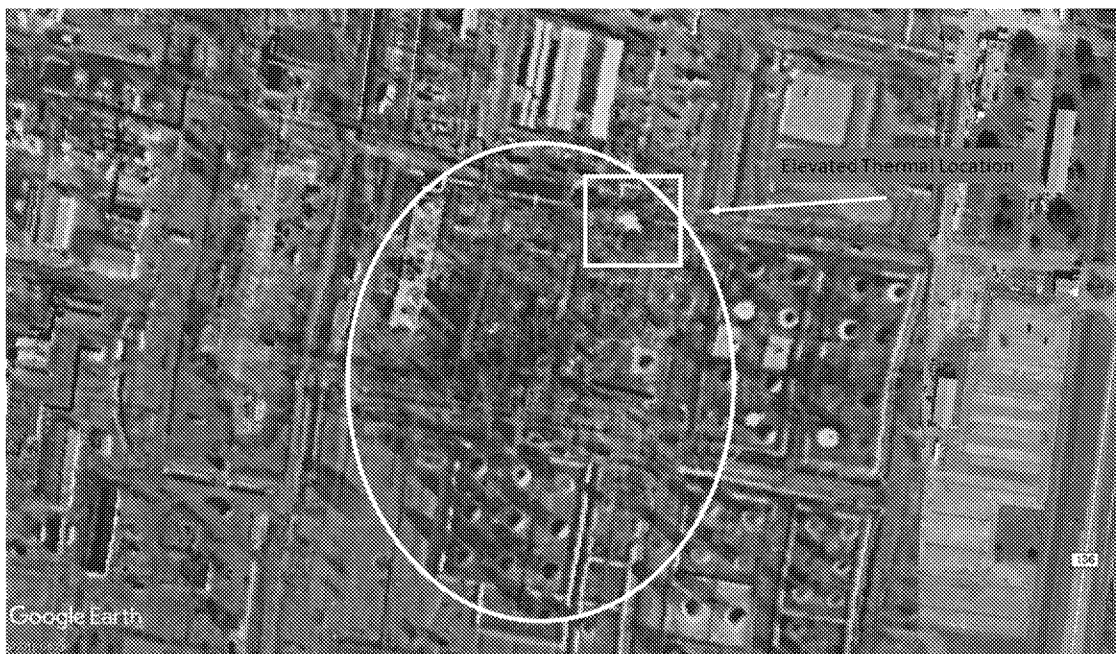
Figure 4: -- 3 band IR Image, Flight 10, Run 8, South 4 Group Thermal Image

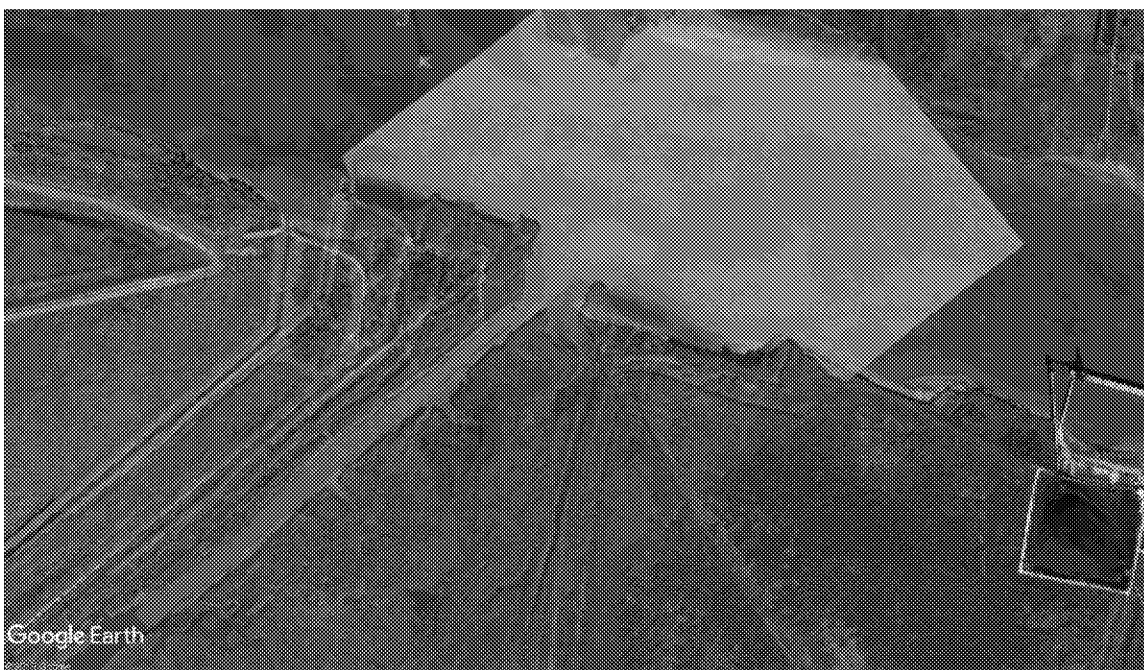
To check for possible oil migration from the site, ASPECT was flown along a waterway leading from the east side of the facility to the Naches River. Figure 5 show an IR image of the waterway flowing into the River. No sheen can be seen in the image.

Figure 5: -- 3 band IR Image, Flight 10, Run 10, Waterway Image, South 4 Group Fire

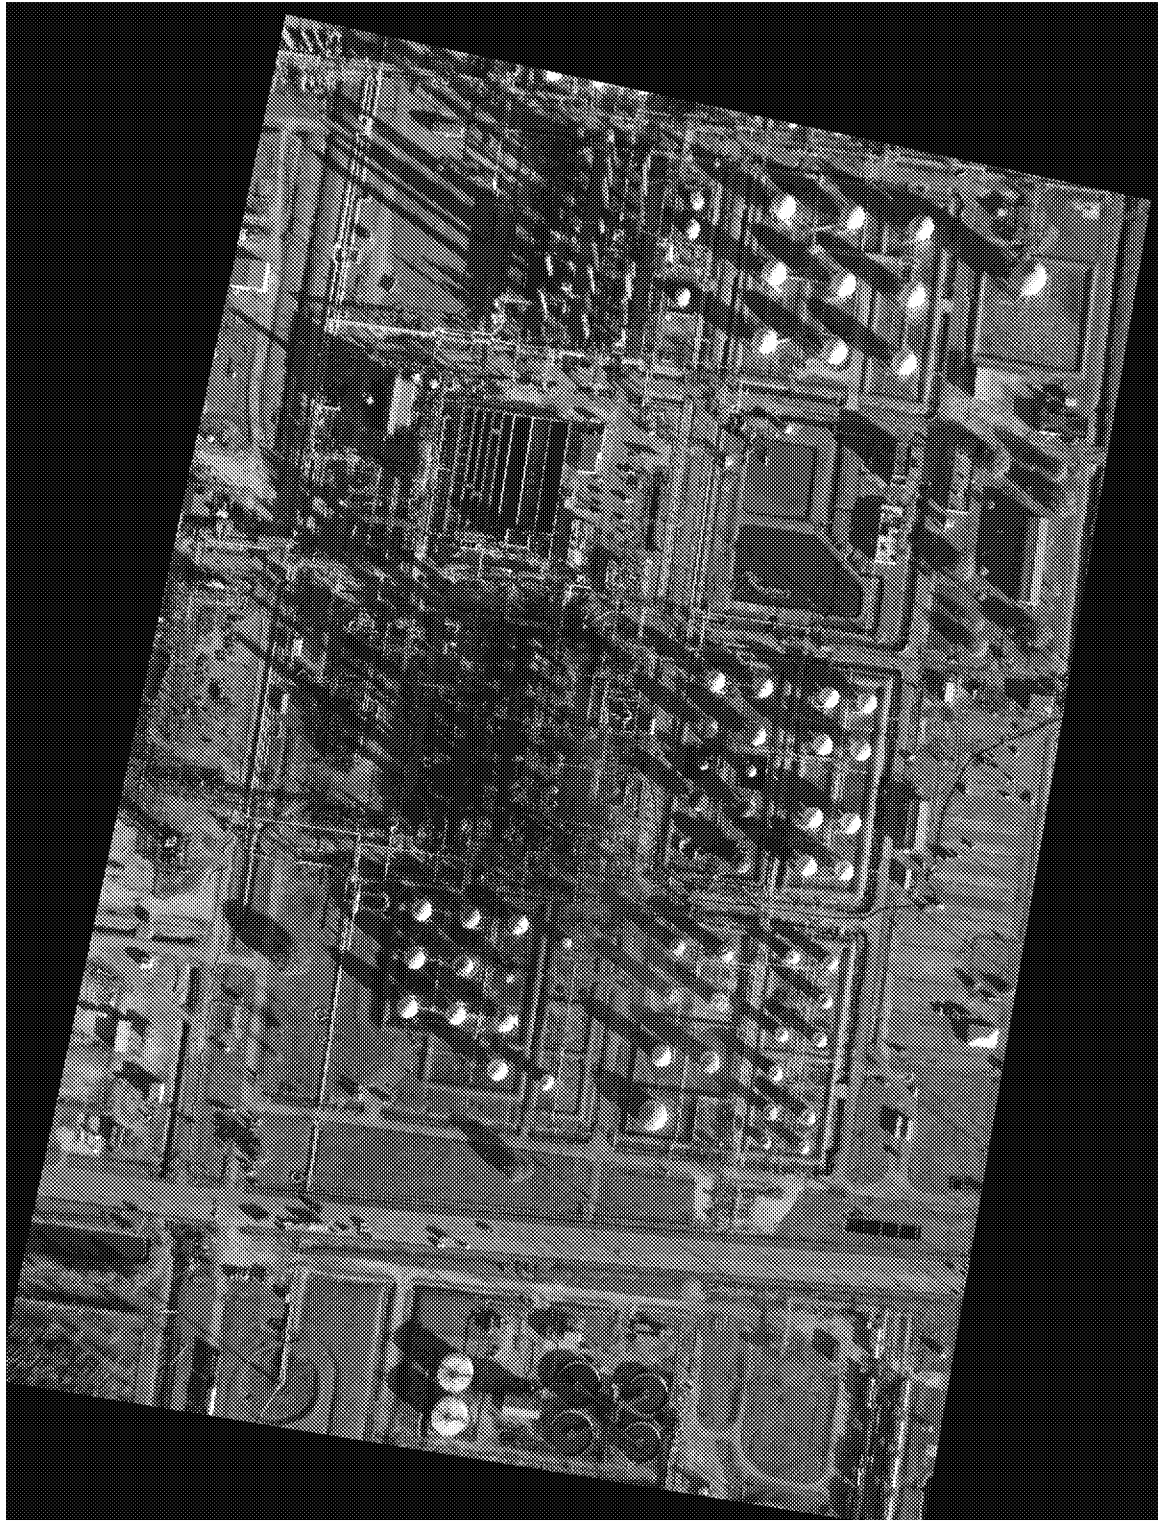
A full set of high resolution aerial digital photography were collected as part of the flight. Figure 6 shows a representative image collected as part of each pass. Consistent with the crew report, a small amount of smoke was observed being emitted from the site. The oblique image in Figure 7 shows the presence of one fire on the north side of the unit. At the time of the oblique collection, one water cannon was in operation.

Figure 6: Aerial Image, Flight 10, Run 6, South 4 Group Fire.

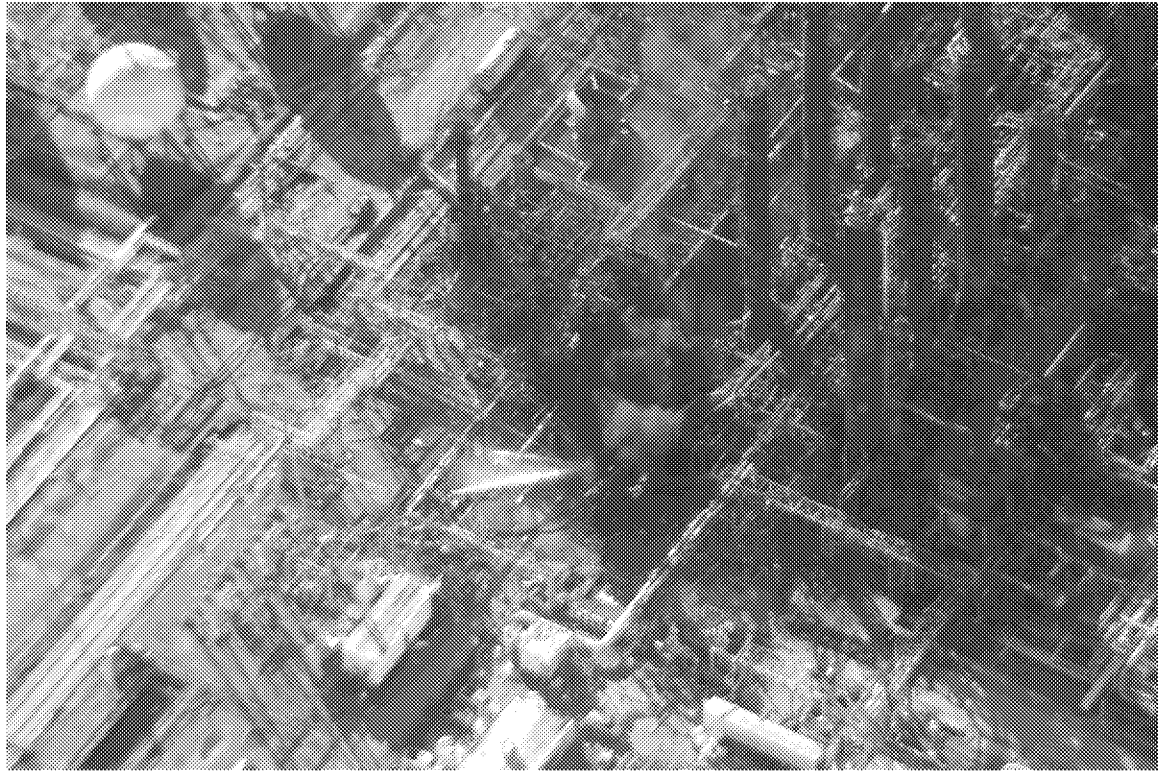
Figure 7: Oblique Image of the South 4 Group Fire

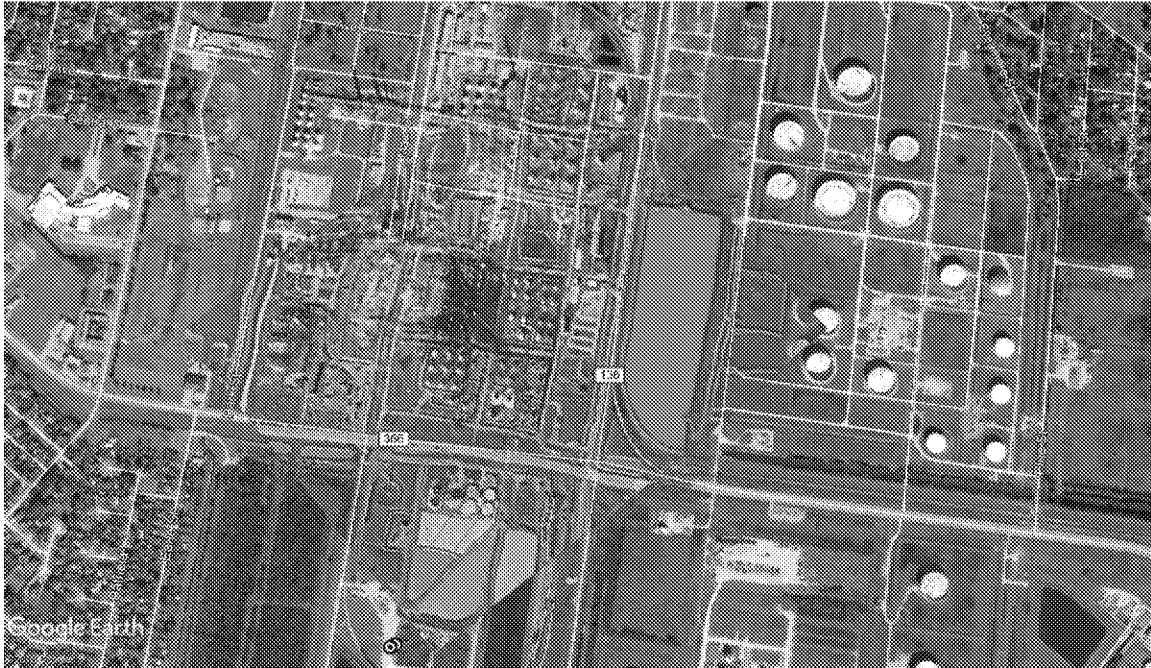
A total of 2 test and 8 data collection passes were made in the proximity of the fire and an infrared line scanner image was generated for each pass. Figure 9 shows a typical 3-band infrared image obtained from data collected for Run 2. Examination of the frame shows that four water cannons are being used to cool the central part of the unit. No chemical plume can be observed being emitted from the facility. A close-up image taken from pass 7 is given in figure 10. The reactor towers tend to show temperature higher than the surround area with a defined high temperature location on the northern part the process unit. Figure 11 shows the waterway entry into the Naches River. Analysis of the image does not show a sheen but there does appear to be water flowing into the river.

Figure 9: -- 3 band IR image, Flight 11, Run 2, South 4 Group Fire

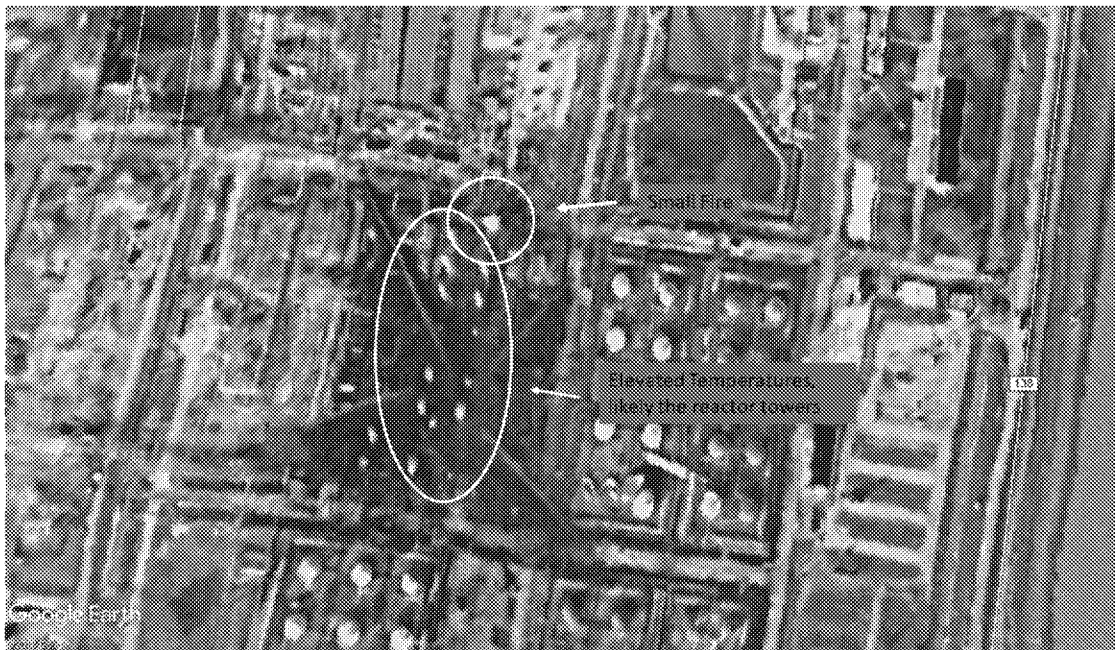
Figure 10: -- 3 band IR image, Flight 11, Run 7, South 4 Group Fire

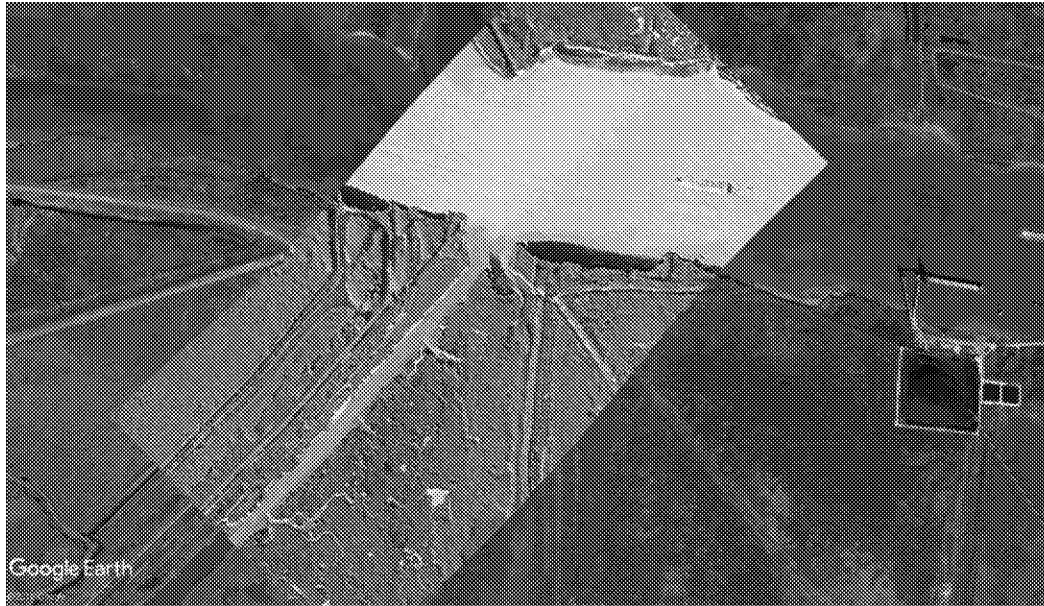
Figure 11: -- 3 band IR image, Flight 11, Run 10, Waterway, South 4 Group Fire

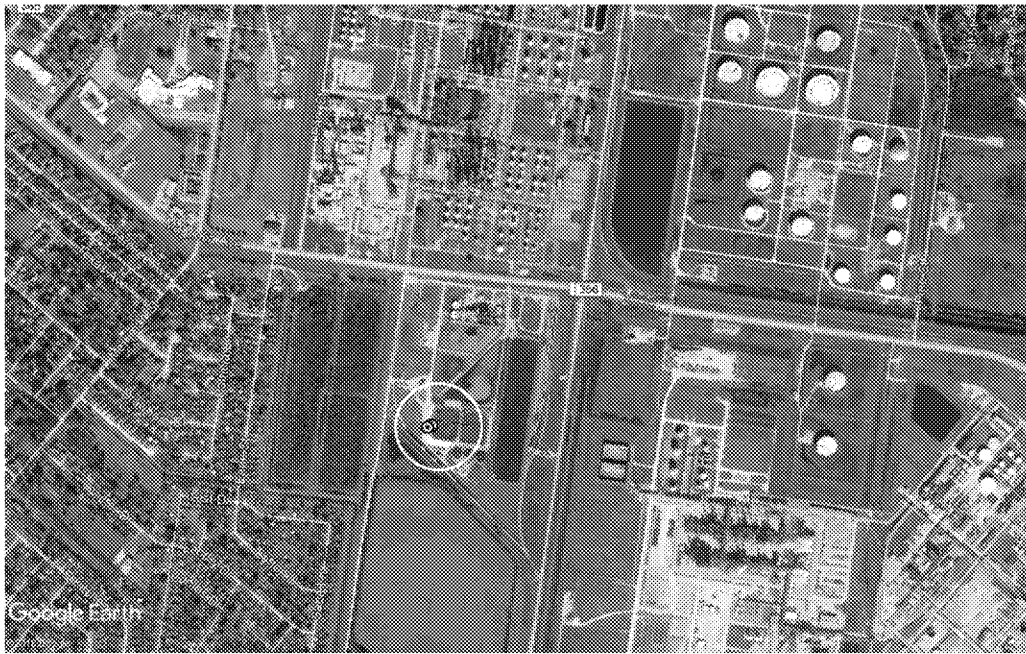
Signatures corresponding to isobutylene were detected due south of the facility near the wastewater treatment plant. Figure 12 shows the location of the detection cluster which had a maximum concentration of 1.57 ppm, just slightly above the detection limit of the system. A summary of data of the data collection is given in table 6.

Figure 12: -- Isobutylene Detection Locations, Flight 11, South 4 Group Fire

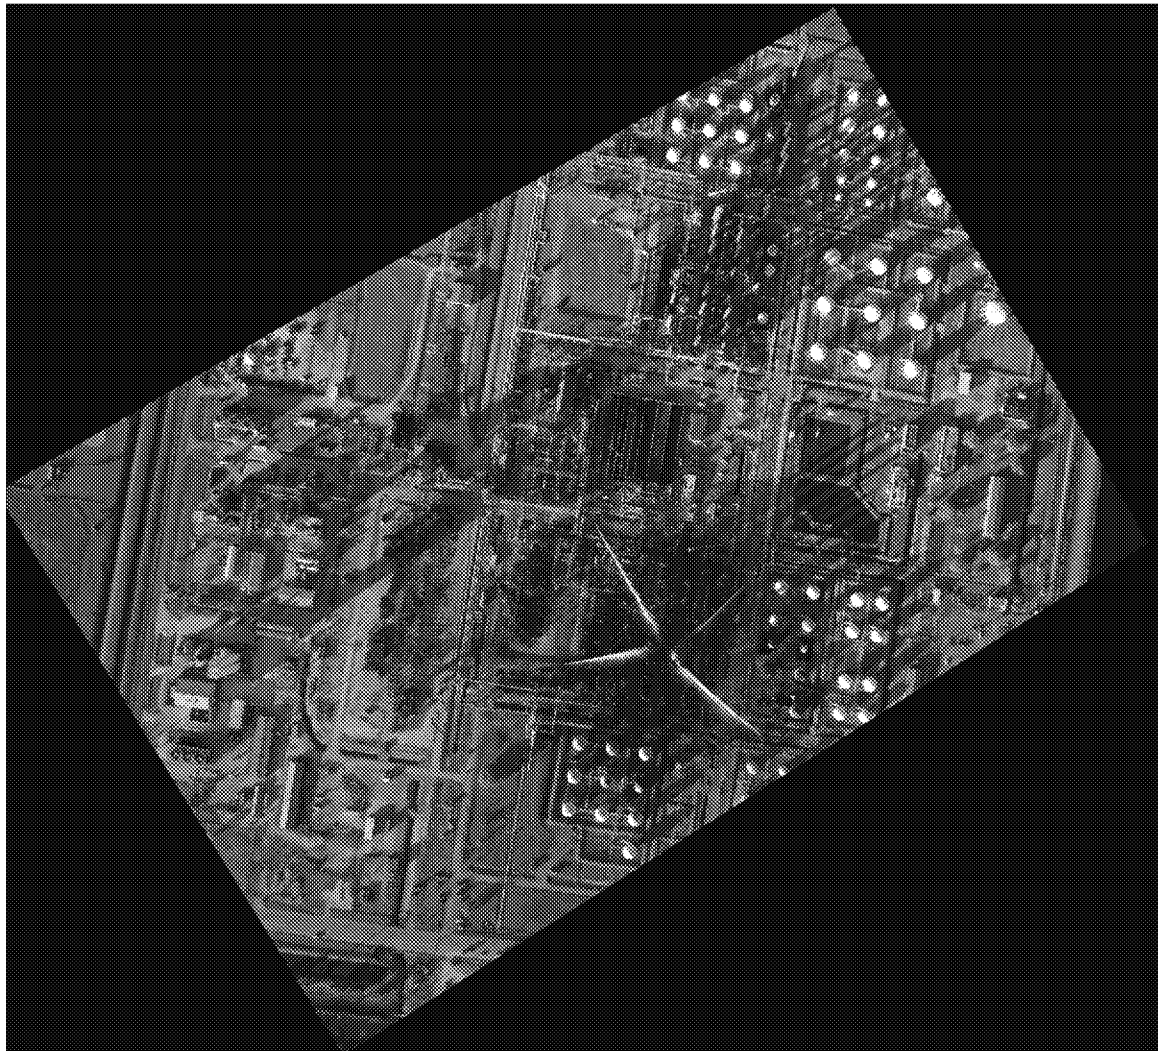
A full set of high resolution aerial digital photography were collected as part of the flight. Figure 13 shows a representative image collected as part of each pass. As reported by the flight crew, very light smoke is being generated by the fire. At the time of collection,

Figure 13: Aerial Image of the South 4Group Fire, Flight 11

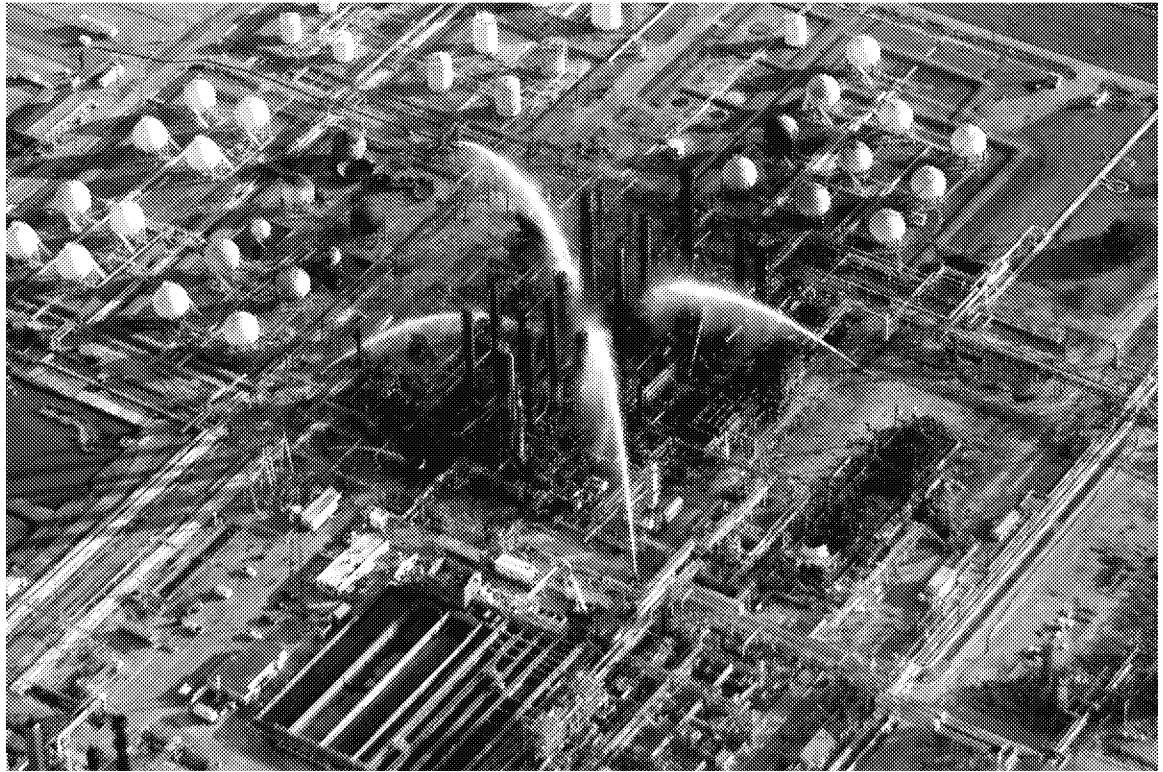
four large water cannons were dumping water into the middle of the process unit (figure 14). A smaller cannon was directing water on the fire located on the northern edge of the unit.

Figure 14: Oblique Image of the South 4Group Fire, Flight 11
